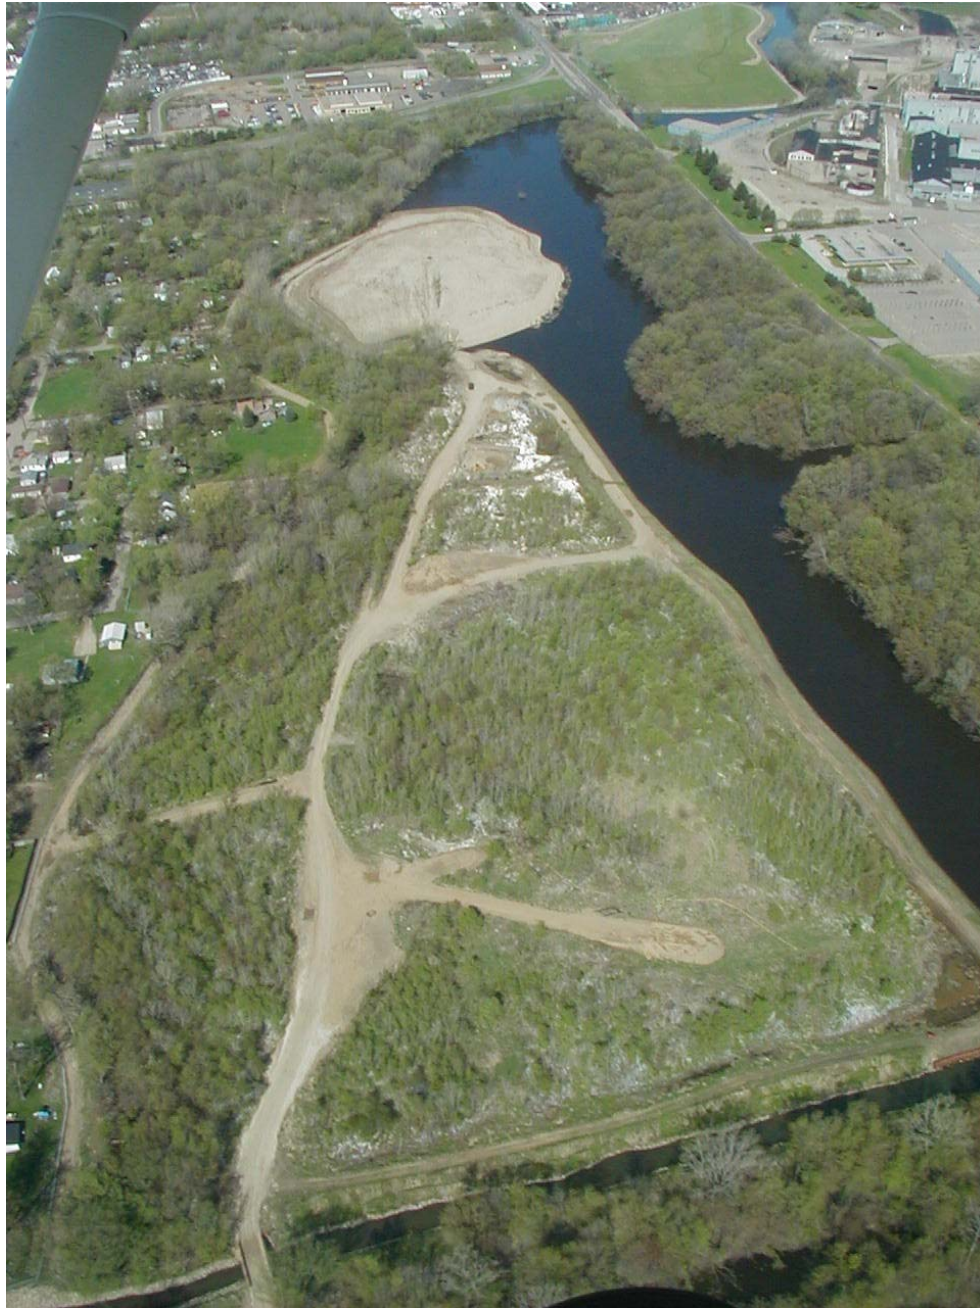
**Photo 1:** Aerial view of the Willow Boulevard/A-site, looking west (downstream). The bottom  $\frac{3}{4}$  of the picture is the A-site. The interim sand cover on the Willow Blvd portion can be seen at the top of the photo. CDM, April, 2001

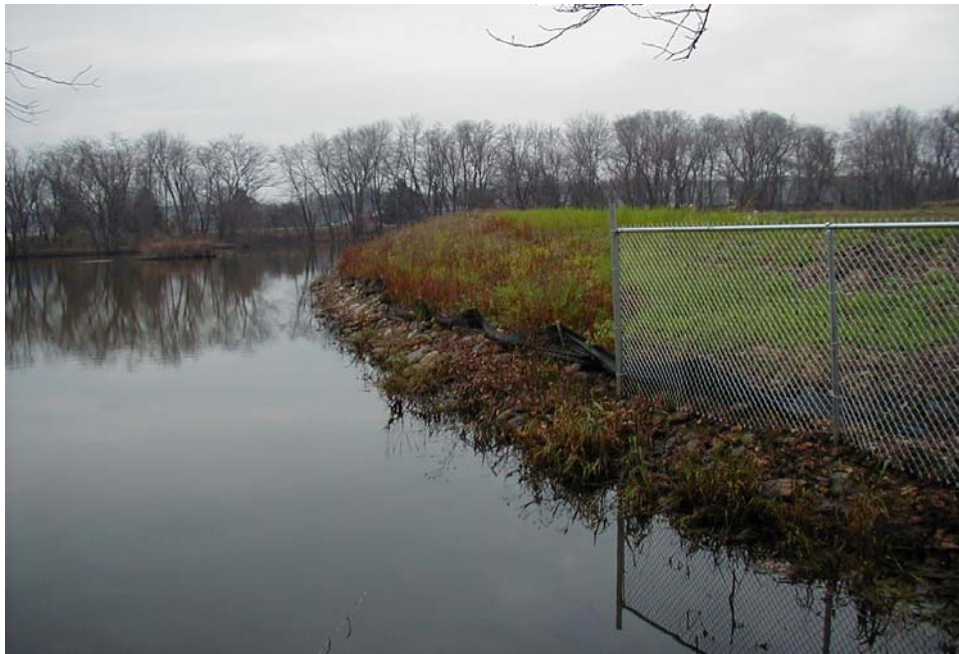
**Photo 2:** Looking north at the western edge of the Willow Blvd portion of the OU. The slope was vegetated to provide erosion control. The current placement of the fence allows passage of trespassers. CDM, 2001.

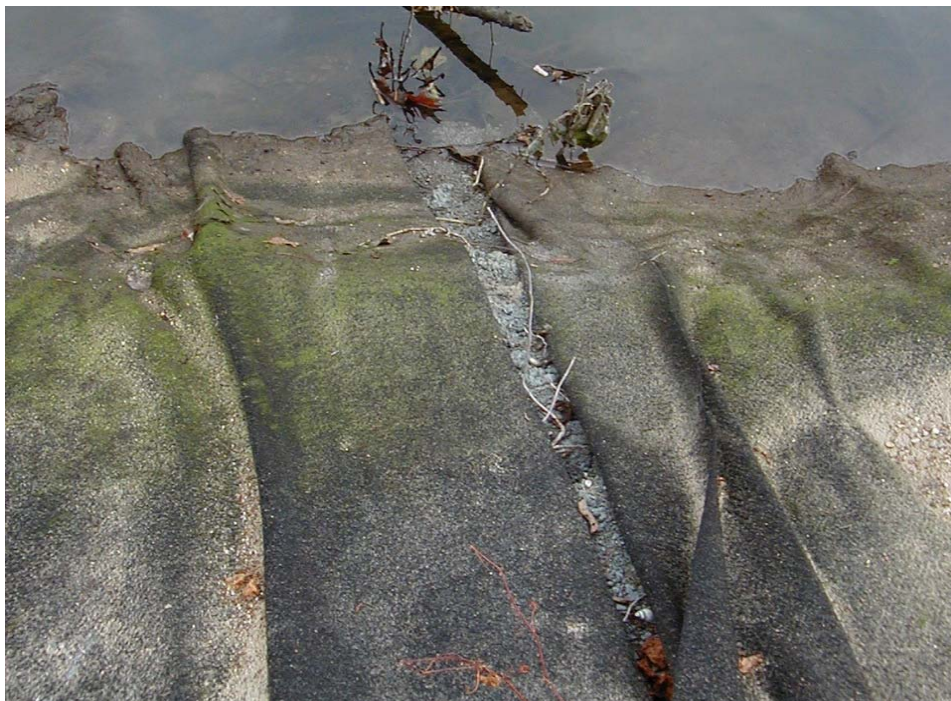
**Photo 3:** Black geofabric on the north bank of the Willow Blvd. portion of the OU. The fabric has parted, exposing gray paper waste. Residual material is visible in the river. CDM, 2001.

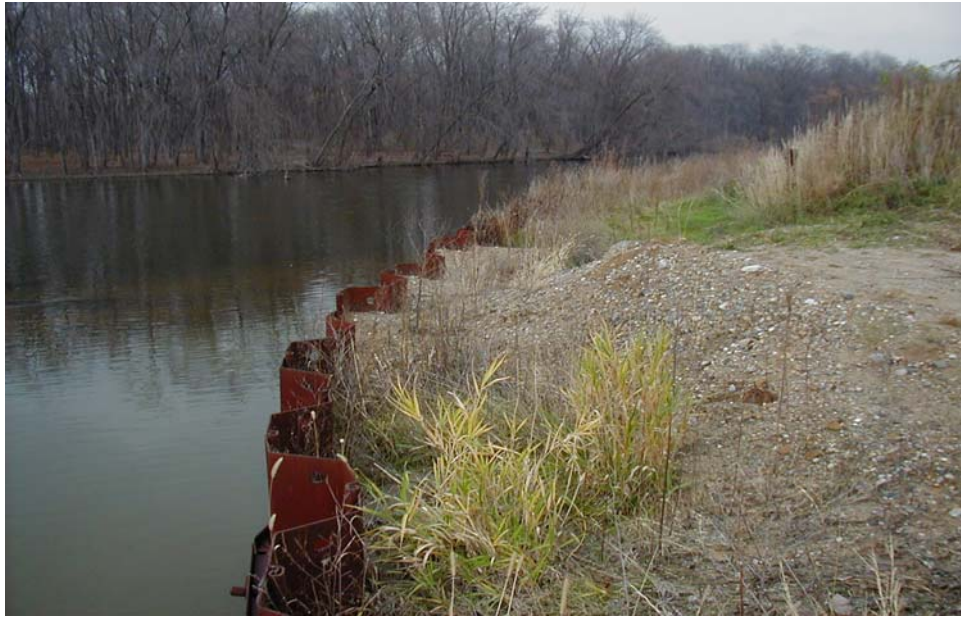
**Photo 4:** Sheetpile along northern edge of the A-site portion of the OU. CDM, 2001.

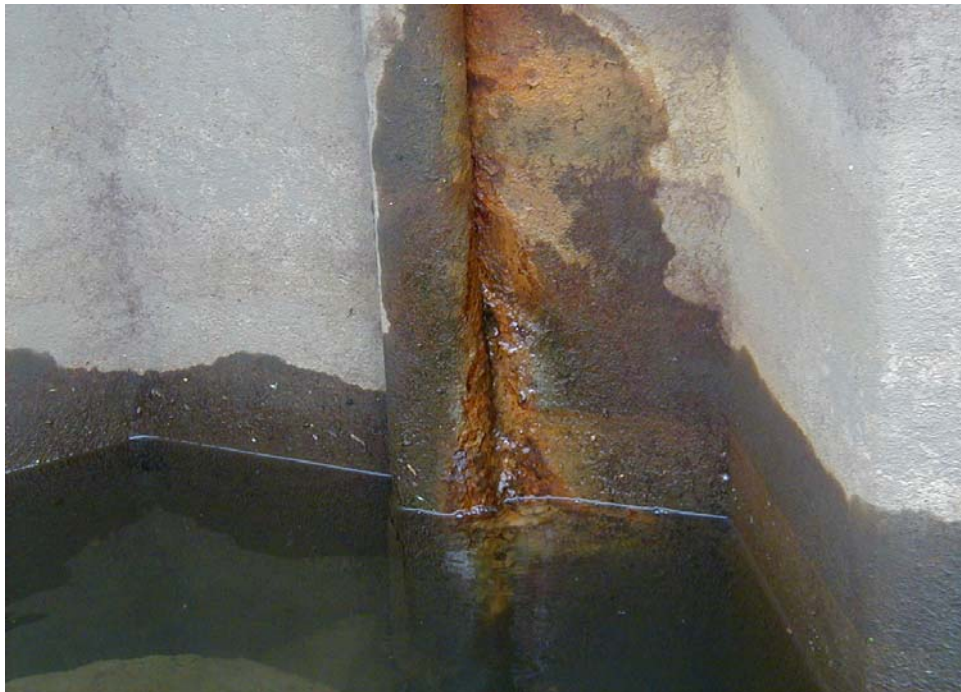
**Photo 5:** At the A-site, evidence of groundwater seepage through a sheetpile seam. (CDM, 2000).

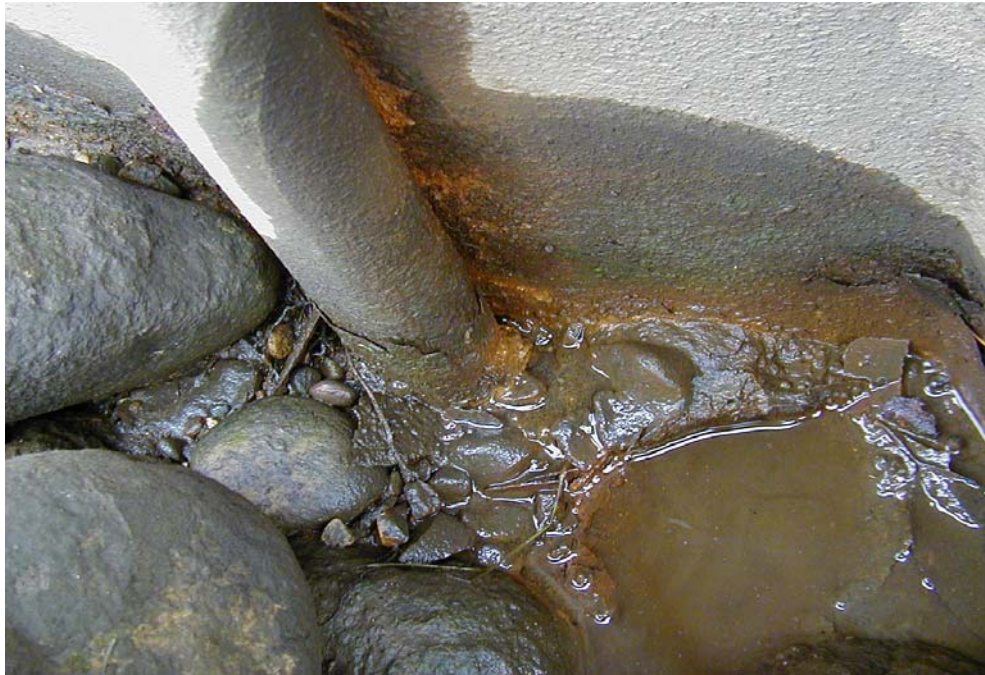
**Photo 6:** A-site sheetpile. Moisture indicates groundwater seepage. (CDM, 2001).

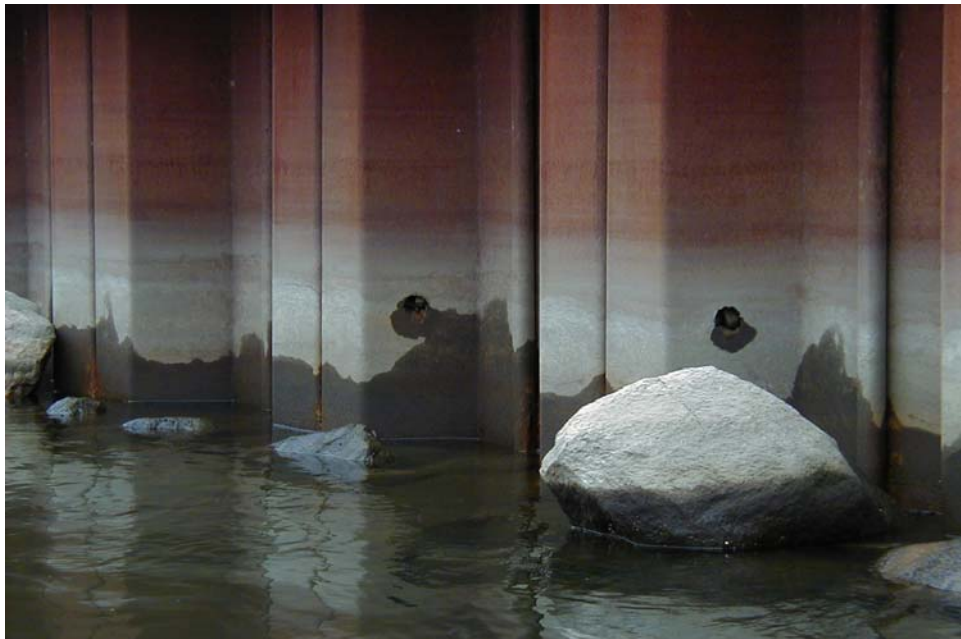
**Photo 7:** Holes in sheetpile at A-site. Moisture indicates groundwater seepage (CDM, 2000).

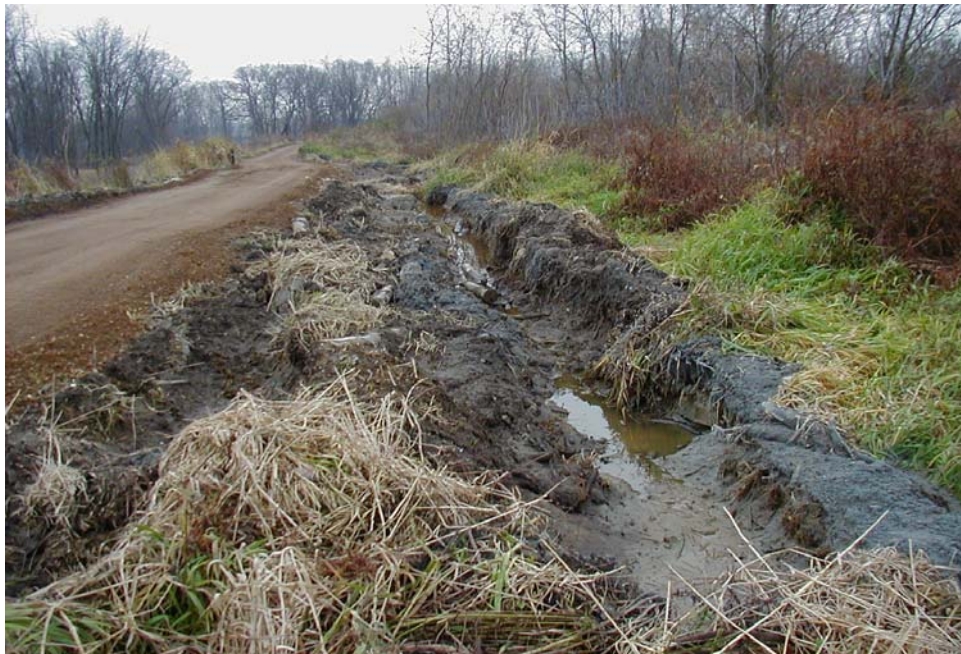
**Photo 8:** Paper residuals exposed at the surface of the A-site portion of the OU. (CDM, 2003).

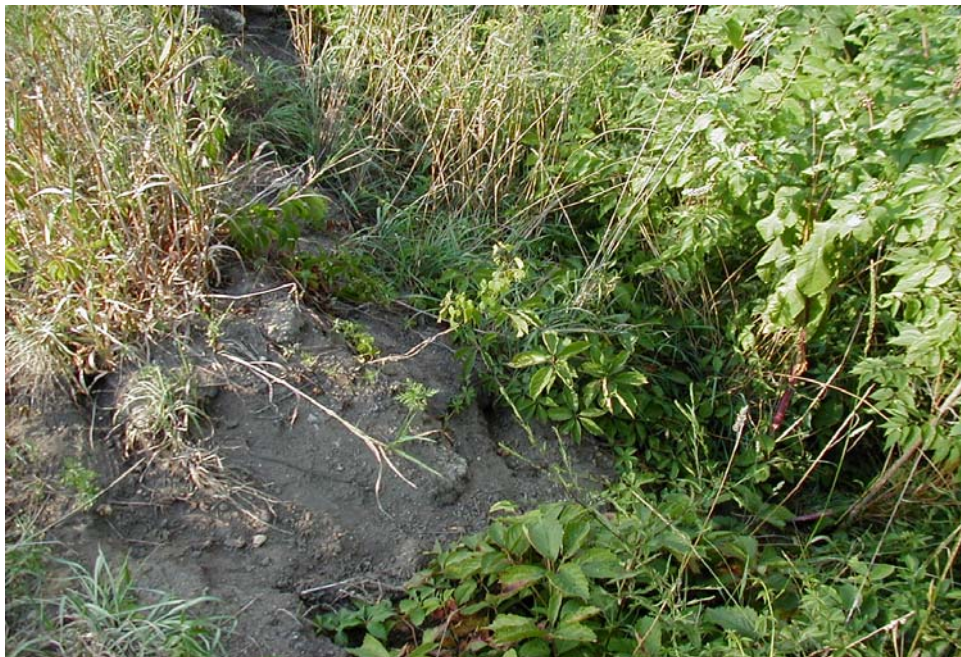
**Photo 9:** Residuals exposed at the surface on east side of A-site. (CDM, 2003).

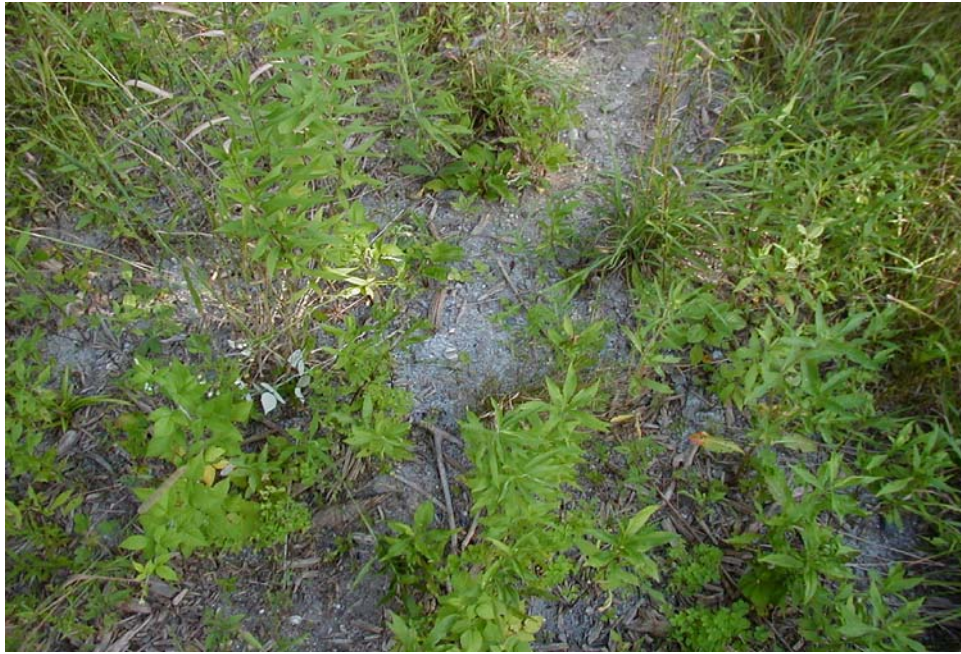
**Photo 10:** Residuals exposed at surface, Area East of Davis Creek (CDM 2001).

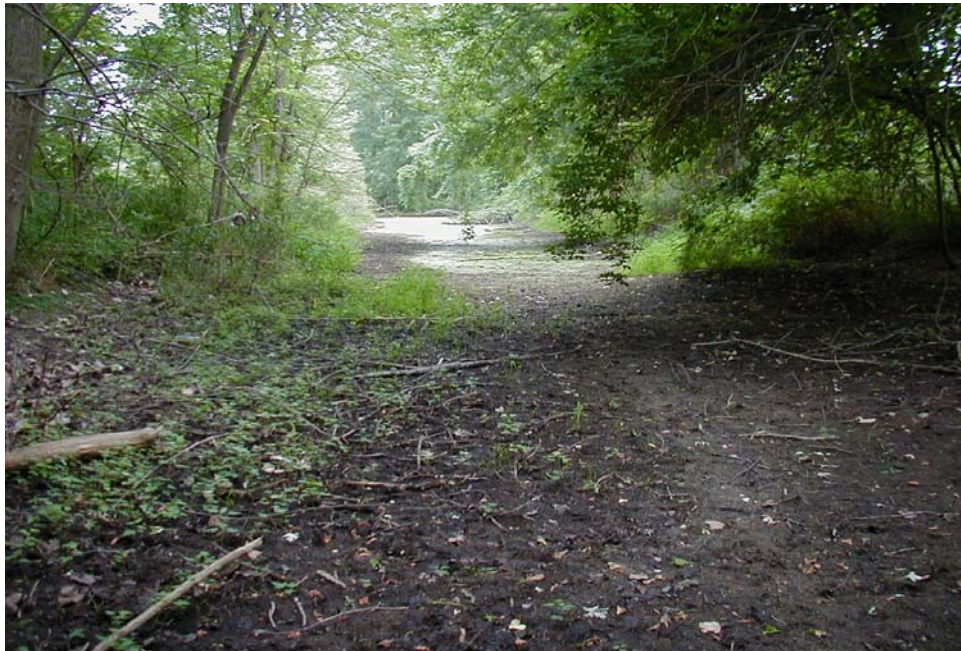
**Photo 11:** Area east of Davis Creek, partially inundated with 2 inches of water (CDM, July, 2003).

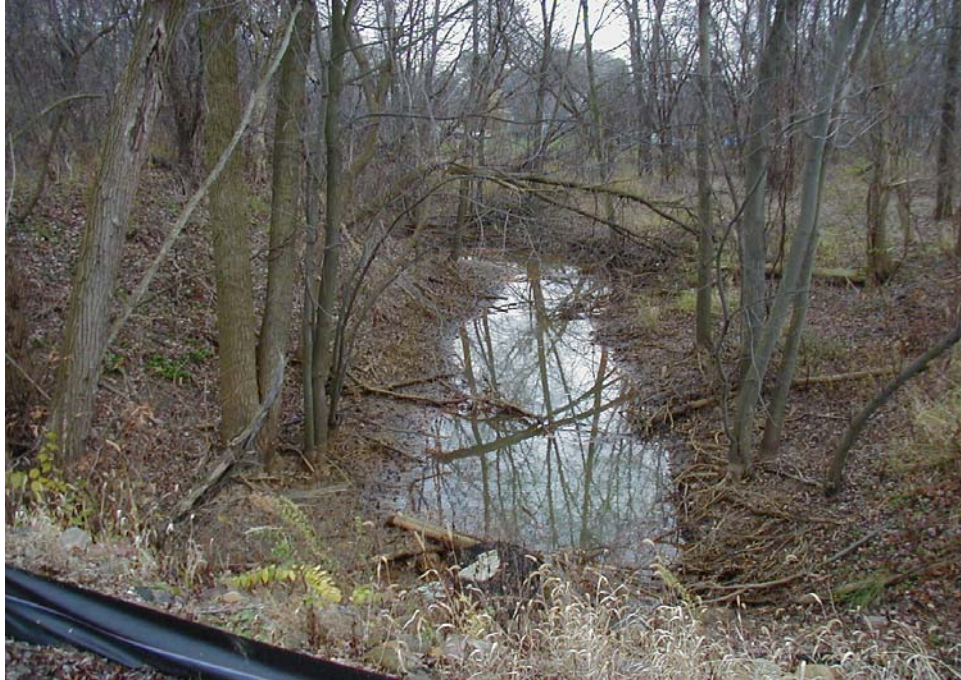
**Photo 12:** Former Olmstead Creek, inundated with surface water. (CDM, 2001).
